World Housing Encyclopedia

HOUSING REPORT

Concrete Shear Wall Buildings

Report #	4
Report Date	05-06-2002
Country	CHILE
Housing Type	RC Structural Wall Building
Housing Sub-Type	Reinforced Concrete Structural Wall Building : Moment frame with in-situ shear walls
Author(s)	Ofelia Moroni, Cristian Gomez
Reviewer(s)	Sergio Alcocer

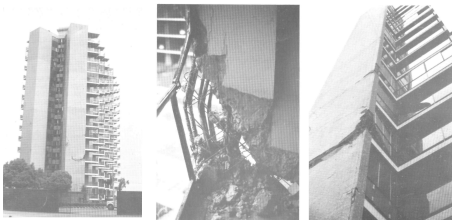
Figure 6: Edificio Acapulco, Vina del Mar, 1985 Llolleo earthquake

Not many buildings existed in southern Chile in 1960, the only damage cited in the literature is the hospital in Valdivia. In 1985 only one building partially collapsed in Santiago (Villa Olímpica) and one had to be demolished in Viña del Mar (El Faro de Reñaca). Important damages occurred in 5 stories buildings (Canal Beagle) that were located on the top of a hill in Viña del Mar where important acceleration amplification have been measured. A few others buildings in Viña del Mar had some walls damaged and some others had non-structural damage. FIGURE 6 shows the Edificio Acapulco building in Viña del Mar, after the 1985 Llolleo earthquake. This building suffered some damage in lintels during 1971 earthquake, that was not properly repaired, so during 1985 new cracks appeared.

Only after an earthquake some buildings have been repaired, when some constructive deficiencies appeared. Edificio Acapulco in Viña del Mar, suffered some damage in lintels during 1971 earthquake, that were not properly repaired, so during 1985 new cracks appeared. FIGURES 6 and 7A show the Acapulco building after the 1985 earthquake and after repaired work was done.

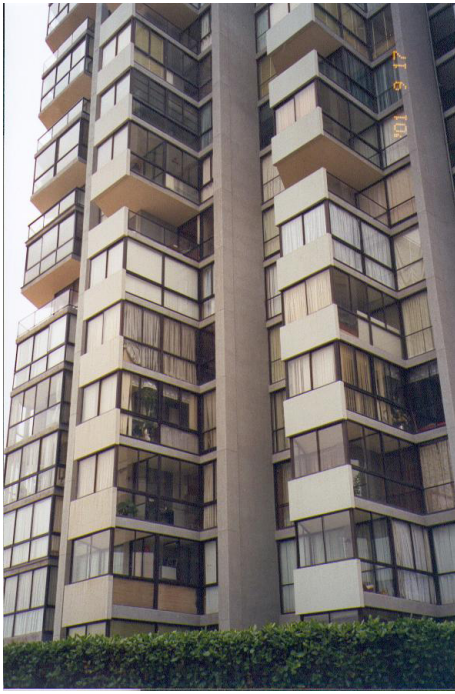
Figure 7A: Seismic strengthening (Edificio Acapulco building damaged in the 1985 Lloleto earthquake). A column has been added to the wall exterior.

This is not a common activity in Chile. FIGURES 7A and 7B show strengthening of earthquake damaged building shown on FIGURE 6. Columns have been added to the extreme of one wall.

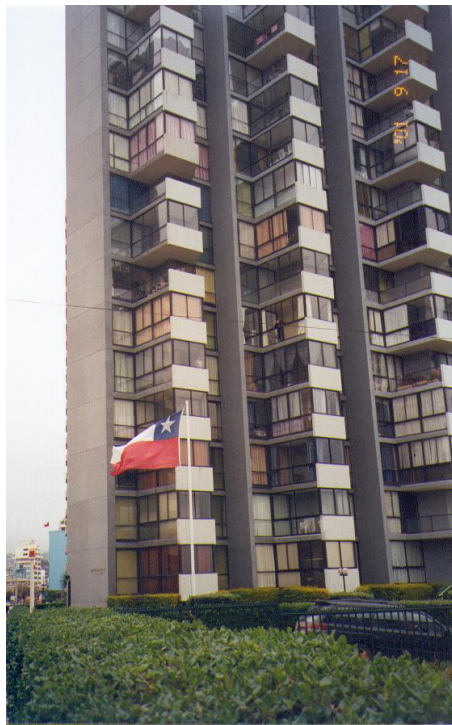
Figure 7B: Seismic strengthening (Edificio Acapulco building). The exterior wall has been thickened with a new steel mesh.
